Gigabyte P35K Laptop Hard Drive Replacement

This repair guide will walk you through the process of replacing a hard drive in the Gigabyte P35K laptop.

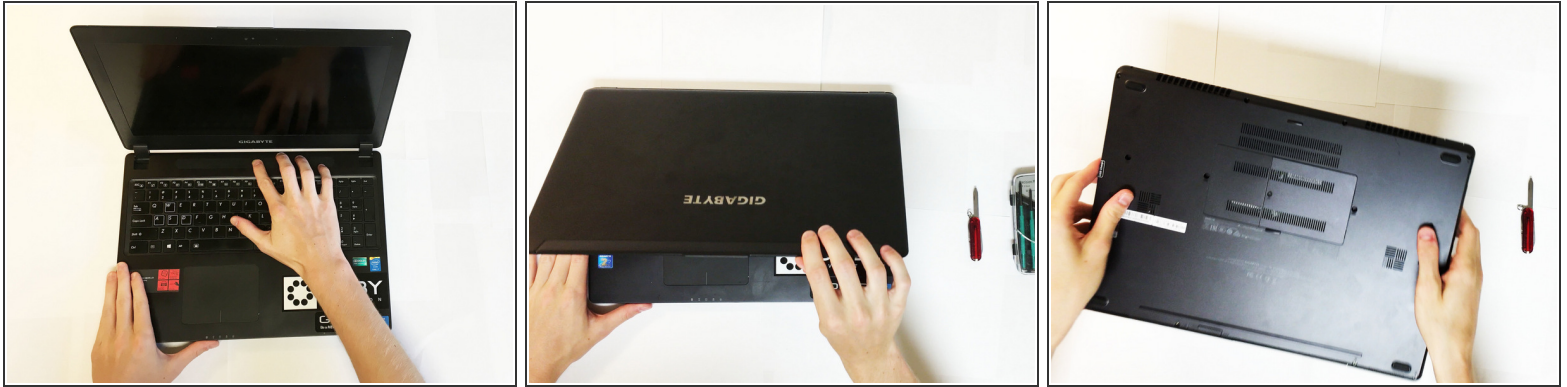
Step 1 — Hard Drive

- Fully power off the laptop.
- Close the lid.
- Flip the laptop over.

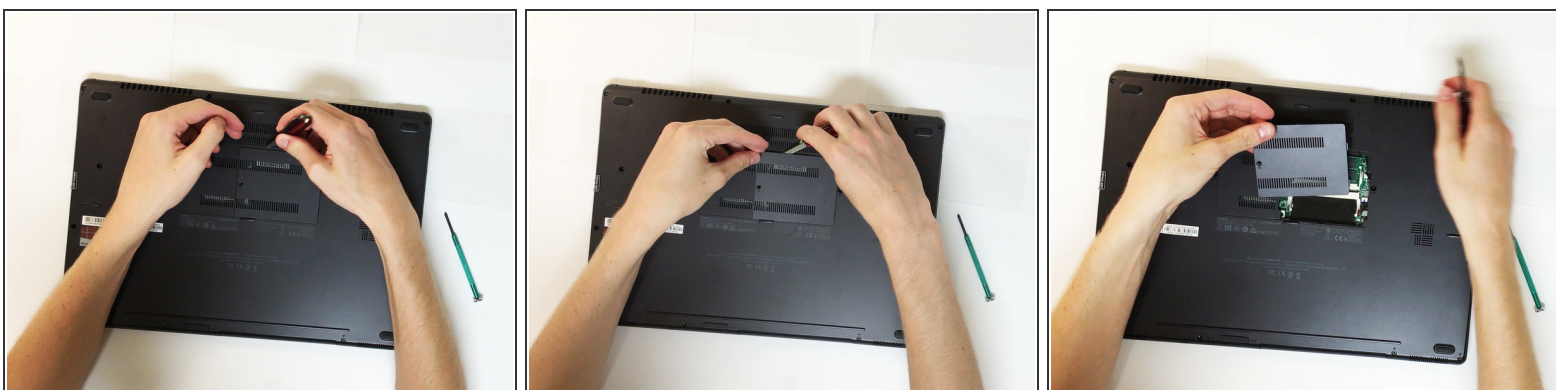
Step 3

- Remove the small plastic back plate.
- ⓘ Use a small flat head tool or knife to lift the plastic back plate and then use your hands to gently remove the plastic plate.

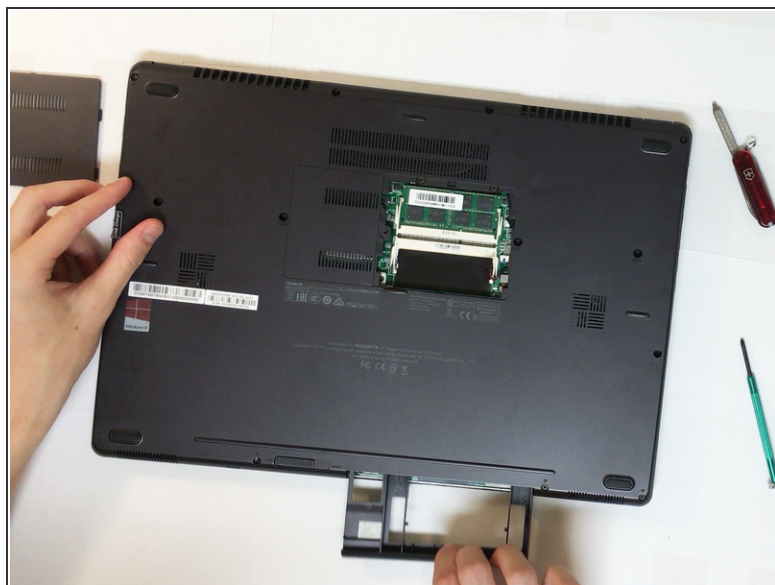
Step 6

- Remove the removable drive bay or CD drive, whichever one is currently present in the laptop.

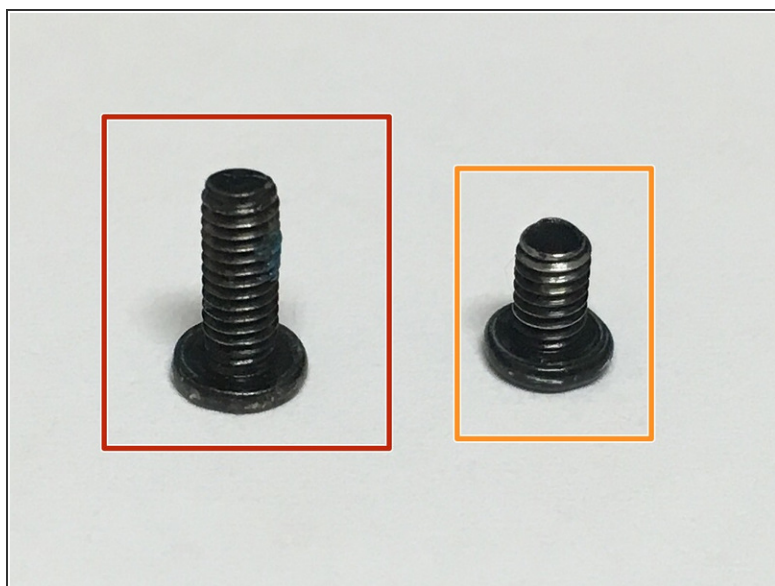
Step 7

- Remove the 8 longer 7.0mm screws from the top and bottom of the laptop.
- Remove the 6 shorter 5.0mm screws from the middle of the laptop.

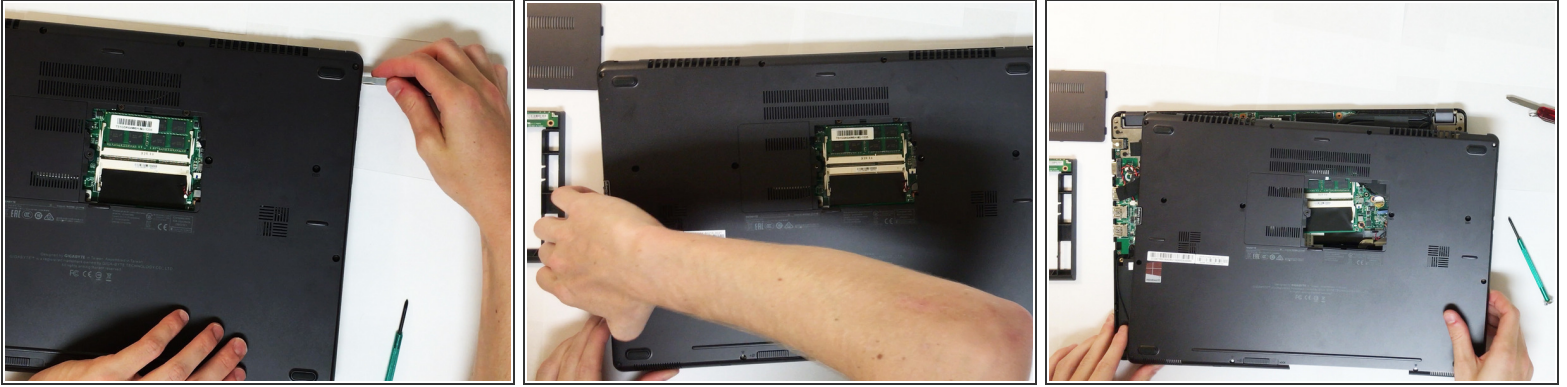
Step 8

- Beginning from the hole created by removing the drive bay in step 6 and moving in a counterclockwise direction, begin separating the base by gently prying between the seam separating the base from the motherboard, using either your fingernail or a small flathead tool.
- ❗ During this process you may hear small pops which is just the plastic releasing from the motherboard.

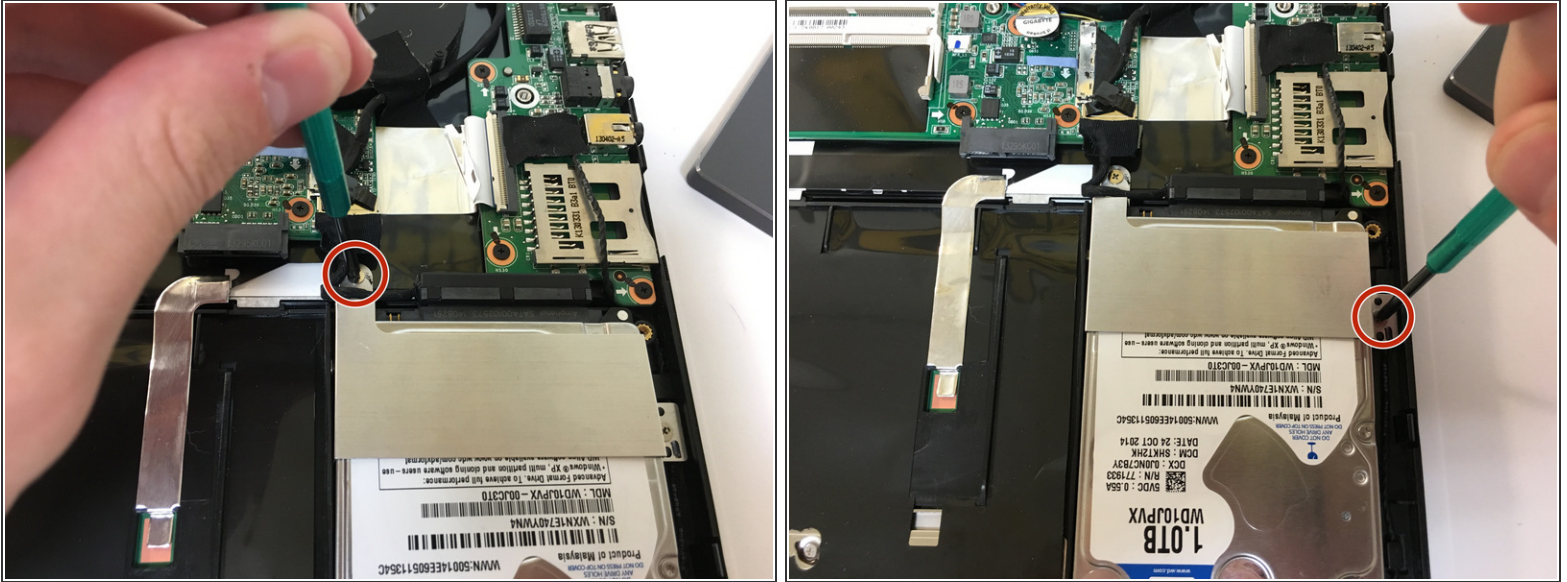
Step 12

- Remove the two screws holding the hard drive in the laptop.

⚠ There is still a SATA cable holding the hard drive in the laptop so be careful after removing the screws.

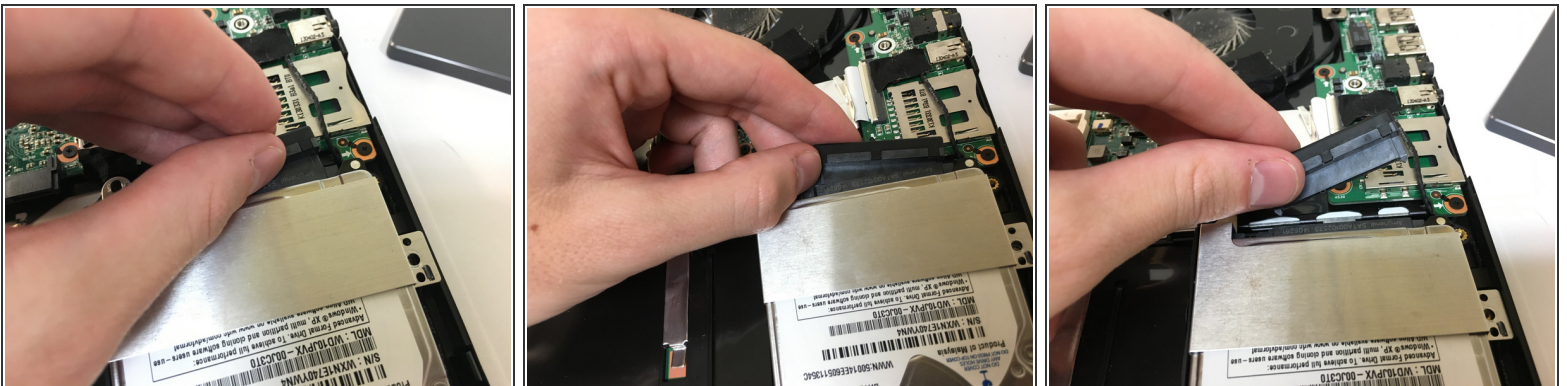
Step 13

- Remove the SATA connector by gently prying the far right, and then the far left of the connector until it slides out of the hard drive.

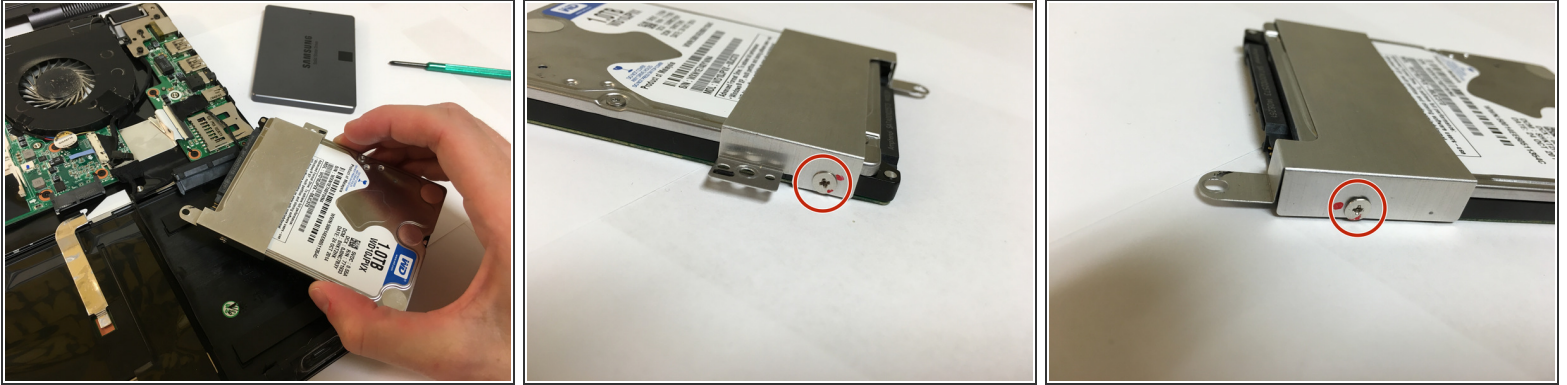
Step 14

- Remove the hard drive from the laptop by picking it up.
- Un-screw the metal holder by removing two more screws, one on either side of the hard drive.
